THE PROGRESSIVE COLLAPSE EVALUATION OF BUILDINGS DUE TO BLAST ATTACKS

***Abstract:** The paper presents the evaluation of the potential of occurrence and propagation of the progressive collapse for an industrial building made of precast and cast in place elements. The performed experimental test aimed to initiate the collapse by destroying, through explosion, a column situated at the ground level, on the contour of the building, at half the distance of the long side of the construction, using charges placed in boreholes. The obtained results highlighted the importance of the manner in which the structure is designed and built, of the height regime and structural conformity, on the collapse.*

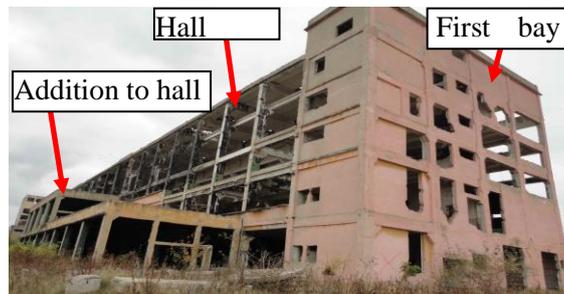
Figure 1 The section on which experimental tests were performed

The building was made of four sections, designed as reinforced concrete structures. The main elements (columns, transversal beams, roof elements) were precast and the longitudinal and secondary beams, the intermediate floors and the access stairs were cast in place. The further description of the building will concentrate on the first section, Figure 1, the one subjected to the experimental study.

The structure of the section was regular in plan, with 9 bays and 4 spans, each having 6m, Figure 2. The first bay had the height regime G+5S, whereas for the other bays the height regime was G+2S (the last floor was built on the height of the 2nd, 3rd and 4th floors and on the first bay), Figure 1. The last level of the structure, between axes 2 – 10, was designed as a production hall with a high clear height (11.30m), with two spans each of 12m, with running beams placed on the cantilevers of the columns at the elevation of +17.75m, where gantries necessary for carrying out the production processes were installed. The intermediate floors were made of cast in place reinforced concrete (RC) elements having the thickness of the concrete slab of 20 cm for the first level and 15 cm for the second level. In order to efficiently withstand and redistribute the live loads, the floors had intermediate secondary beams (GS-25x50cm), arranged at a distance of 2m between the axes, on the longitudinal direction of the building. The precast RC columns were designed with cantilevers on which the transversal beams were supported. The geometrical dimensions and the reinforcing details of the columns are presented in Table I.

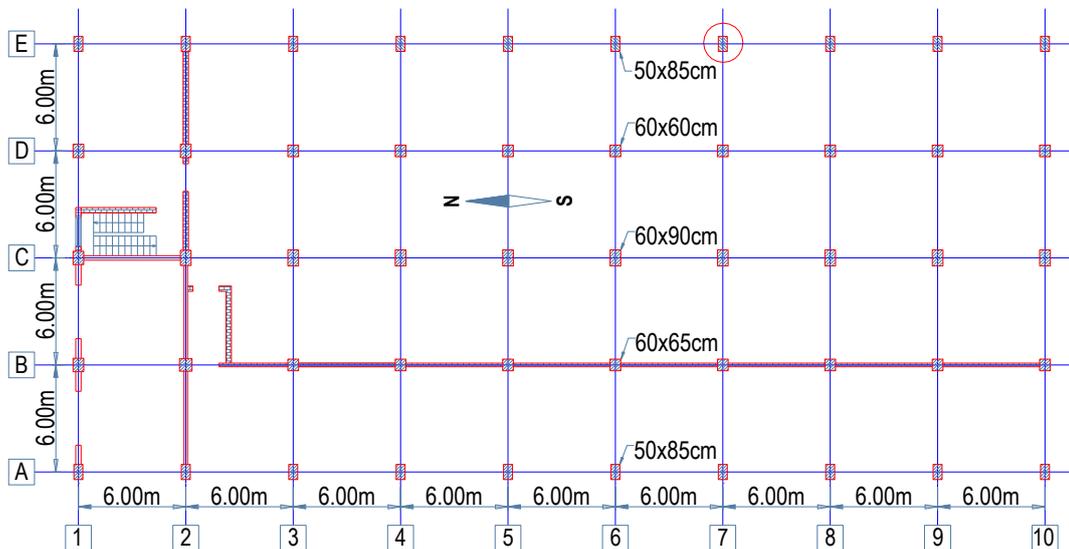
Figure 2 Axes plan of the investigated section of the building

The aim of the experimental tests was the measurement of the vertical displacement of the node located directly above column E7, Figure 2. According to the GSA analysis scenarios for the occurrence and propagation of the collapse, a column situated at the ground level, in the middle of the longest side of the building, was removed. The removal was done instantaneously, through explosion. This kind of removal was possible because the construction was going to be demolished. For the instantaneous removal, explosive charges placed inside several boreholes made directly into the column were used, Figure 4.

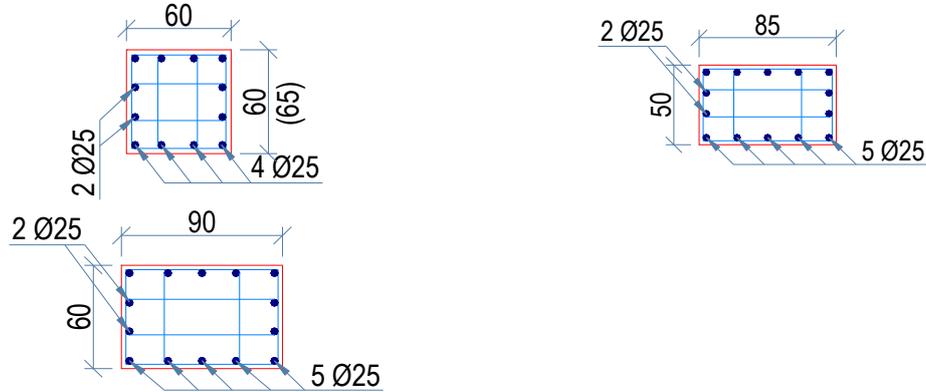
Columns for the ground, first and second level

Table I Geometry and reinforcing details of the columns

All the stirrups for the columns are $\text{Ø}10/10\text{cm}$

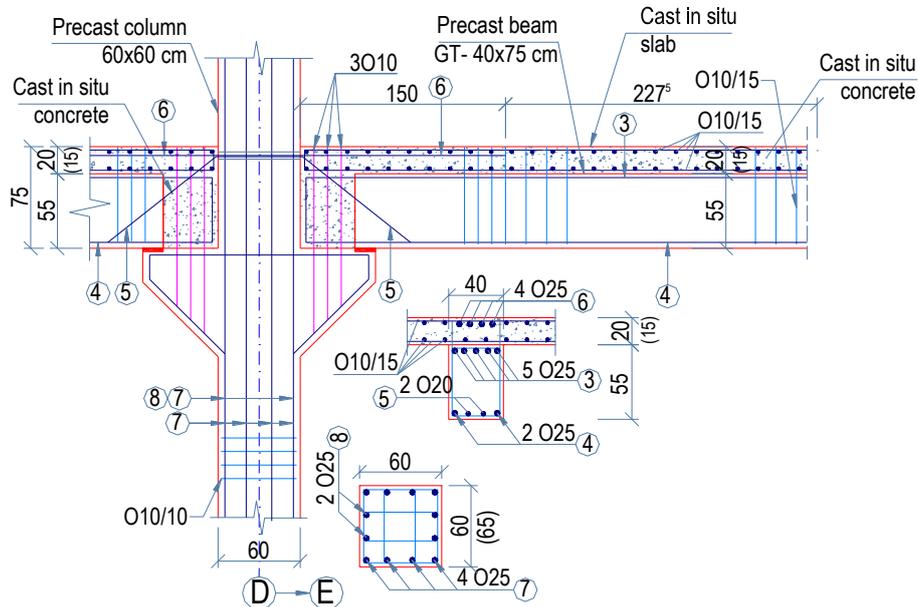
Figure 3 Transversal precast beam - precast columns joint details

The transversal beams (A-E direction) were precast and supplementary concrete was cast in place over them, on the cantilevers of the columns, to

ensure the appropriate structural behavior (all elements working together as a whole), Figure 3.

Two of the types of the longitudinal reinforcing bars of the beams (marks 3 and 4) stopped at the column and the rebars mark 5 along with the rebars mark 6 ensured the connection between the beam and the column at the upper part. Also, in order to withstand the shearing forces with high values at the beam ends, in the area of the supplementary cast in place concrete, the longitudinal rebars exiting the beam and the column were enclosed with stirrups $\text{Ø}10/10\text{cm}$, fixed on the cantilevers of the columns and locked in place after the assembly of the longitudinal rebars. At the lower part of the beam the connection with the column was made through metallic plates fixed both on the haunch of the column as well as on the lower part of the beam. The monolithic floors were cast in place after the fixing of these transversal beams which were designed to have at the upper part, on their entire length, elements ensuring their working together with the RC slab.

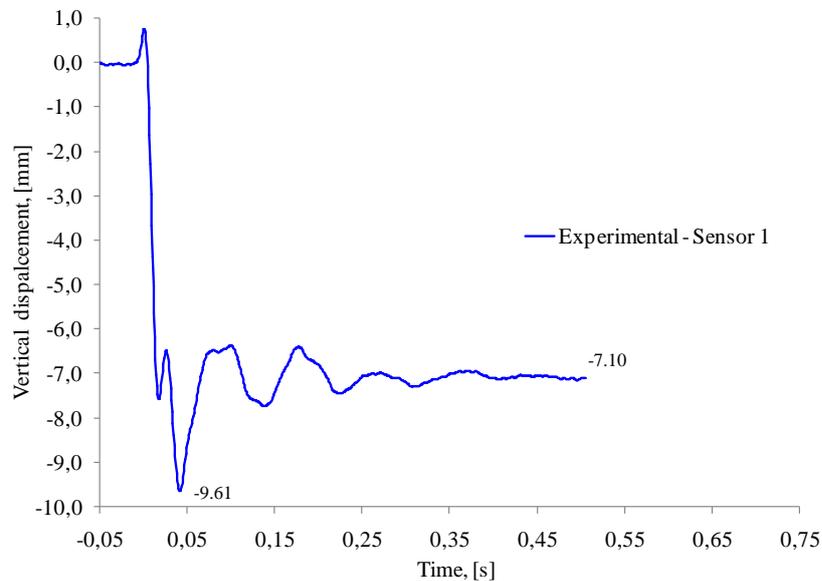
Figure 5 The vertical displacements of joint E7 for the second floor

The vertical displacement of the node located above the blast damaged column is shown in Fig. 5. Immediately after the detonation of the explosive charges the sensor measured a displacement along the positive direction of the axis Z of approximately 1 mm as a result of the action of the shock wave on the metallic support on which the transducer was installed. After the damage of the column the structure did not directly displace until the maximum value was reached. It had a first displacement until the value of -6.5 mm at $t = 0.02s$, followed by a light displacement along the positive direction of the axis Z and then a downward displacement occurred until the maximum value of -9.51 mm at time $t = 0.044s$. As a consequence of the redistribution of the efforts between the structural elements, the structure then oscillated around the permanent value of the vertical displacement, respectively -7.1 mm. It is thus observed that the permanent final displacement represents 66% of the maximum recorded displacement. The maximum vertical displacement of the node located directly above the one destroyed by the blast is comparable in terms of size with the ones

obtained by Sasani et al. [8] and Sasani and Sagioglu [9], for constructions with different height regimes and structural layouts.
